Deep Learning for Visual Inspection and Classification of Tire Defects

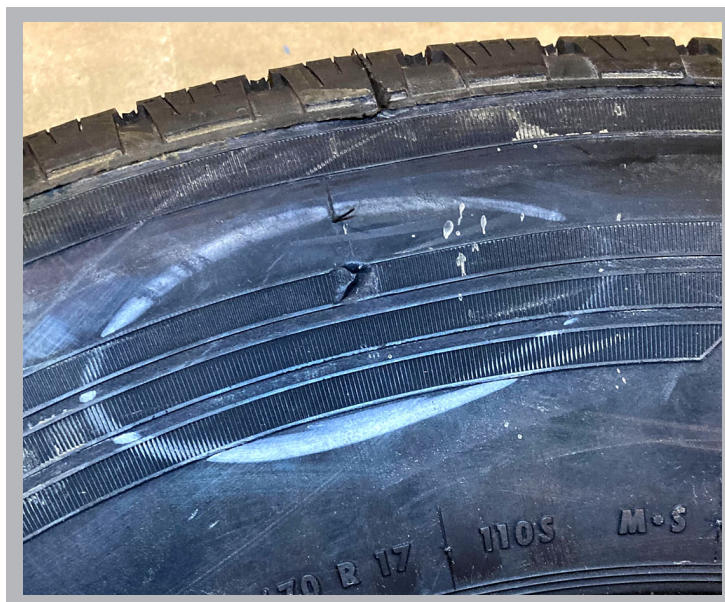
Damage from material handling

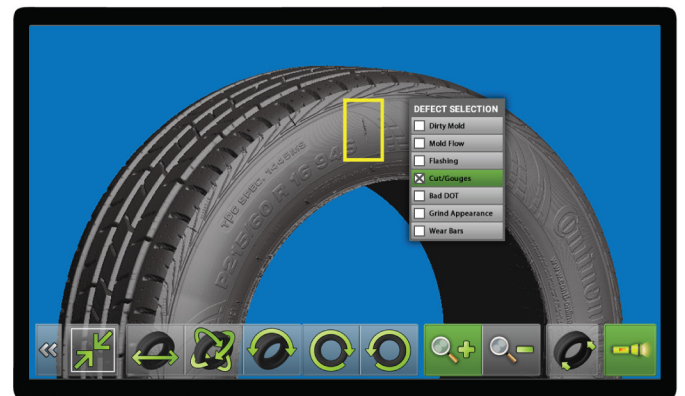
A key element of our Visual Inspection System is its Kiosk, which makes use of a large, high-resolution touch panel to display an interactive 3D tire model, stitched together from the sidewalls and tread geometry images. Potential defects are highlighted (as shown here).

Our Visual Inspection System provides its results and the 3D high-resolution geometry images to a Kiosk from multiple machines containing tire geometry systems. At a Kiosk, an inspector can manually classify each defect by selecting the appropriate classification from a dropdown list, including the ability to dismiss a defect that has been
